Field trip 2

Protection of an hamlet from large volume rock falls: blasting and protection structures – La ripaillère

Forest fire on a rockfall prone area equipped with barriers: case of La Buisse and Voreppe

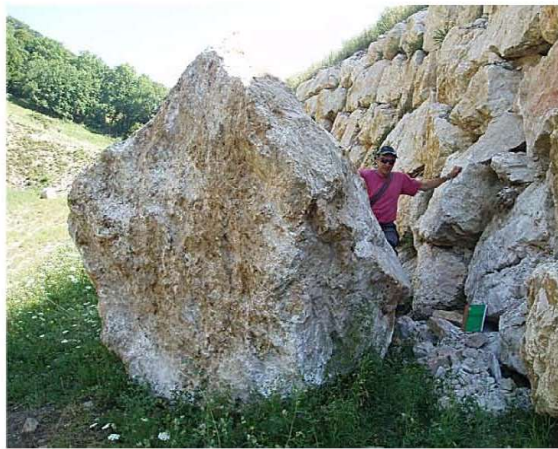
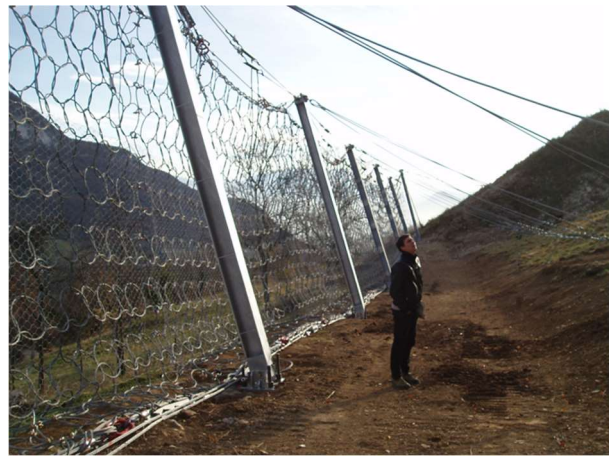
Figure 2. Rock block after interception by the embankment, after the natural event. Additional protection structure built in view of blasting (Photos: Sage Ingénierie)

Decision was made to remove the remaining unstable rock mass, which amounted 3000m³, by blasting. In this perspective, the protection insured by the embankment was extended with a 60m long high capacity flexible barrier. This was motivated by results from specific rockfall trajectory simulations which suggested a larger lateral spreading in the direction of unprotected houses. About 400 kg of explosives were used to blast the compartments and reduce the size of the blocks at release. The blasting occurred on 13 December 2011. The embankment was reached by 7 blocks with a 3-10m³ volume. The very last block was intercepted by the flexible barrier. Most of the blasted volume was thus stopped on the slope. The kinetic energy of the blocks decreased due to the interaction with the slope vegetation (large diameter trees were cut) and to penetration in the ditch.

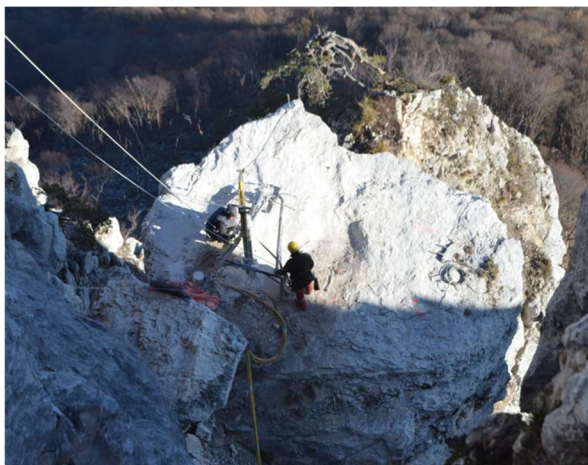
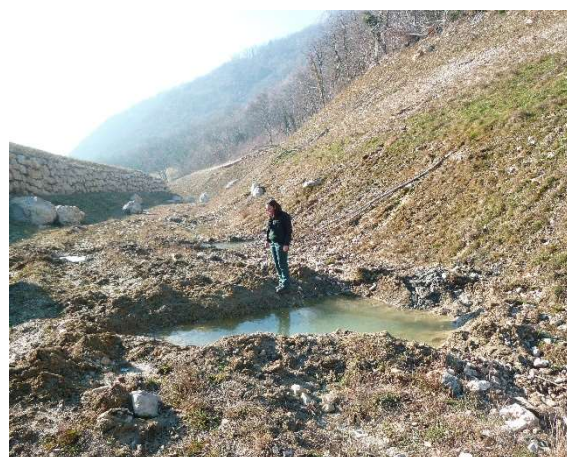
Figure 3. Drilling operation in view of blasting (right). Large impact caused by a rock block in the ditch. (Photos: Sage Ingénierie + S. Lambert)

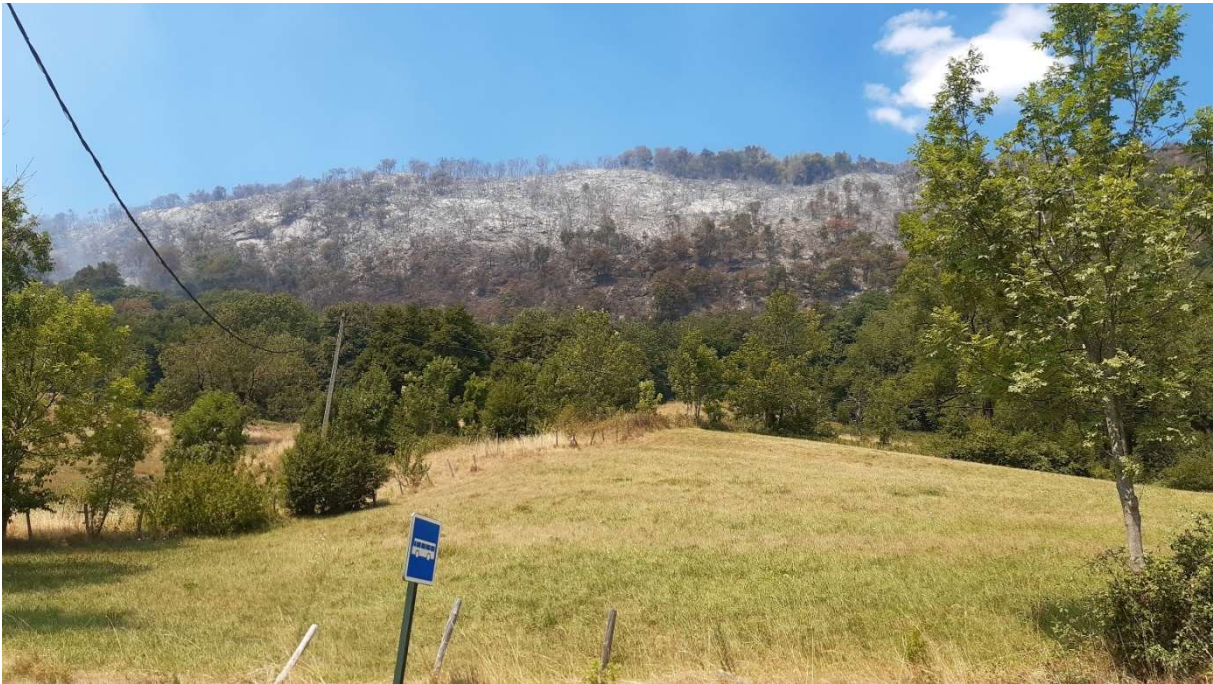
Figure 6 : exposed limestone slopes upstream of Malossane-le-Haut.

The areas crossed by the fire, let appear bare ground and bedrock, occasionally releasing small rock boulders. An increase in the frequency of small boulder falling was observed.

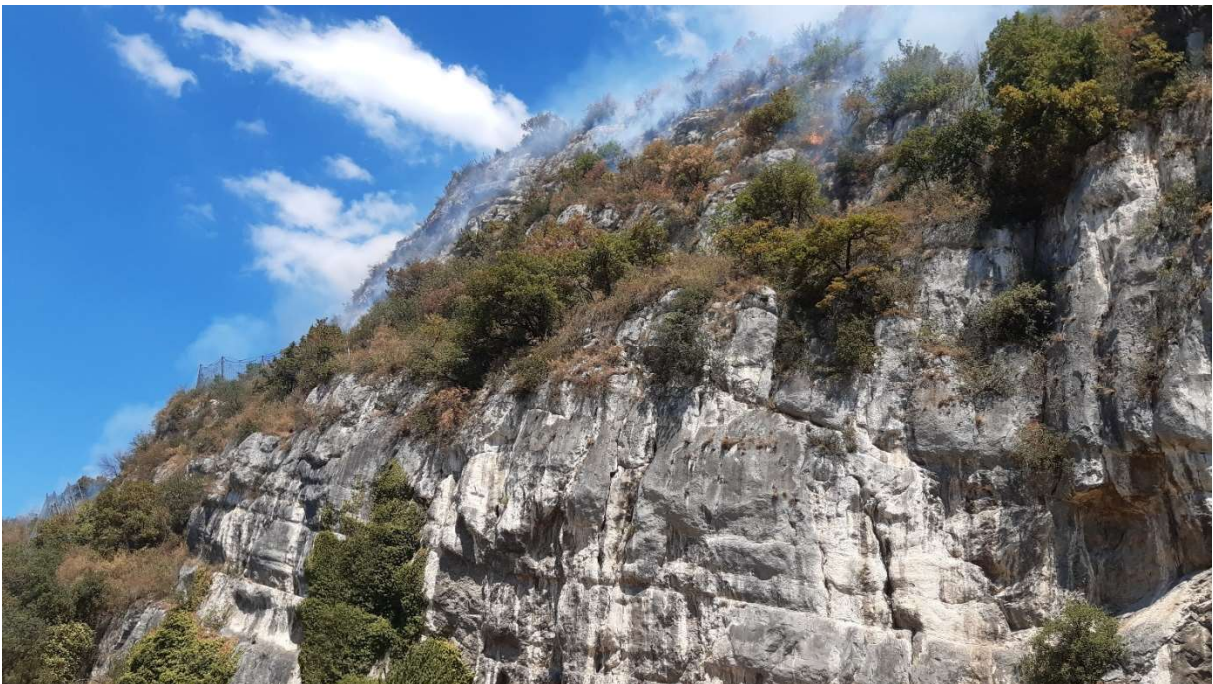
Figure 7 : limestone cliff above Impasse Lavoisier. (fire propagates in its upper part)

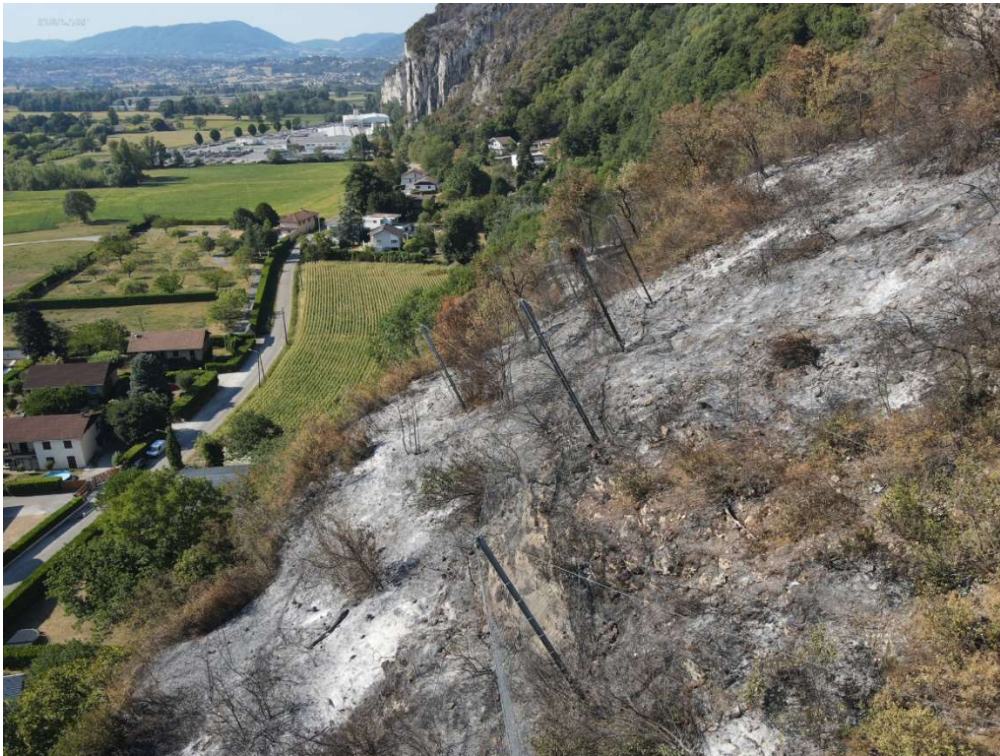
Figure 8 : View of the Balmes structures; northern section (flexible barriers) upstream of the built-up areas. In the background, the hamlet of Le Bourget, which was not affected by the fire. (Source: SDIS 38 – 9 August 2022)

Many of the downstream dwellings were already in a high-risk area in the PPR (risk prevention plan) of the municipality of Voreppe. The rockfall barriers protecting these dwellings are difficult to access because they are located on the ledge above the first cliff upstream of the buildings. Even though these metal works were exposed to the fire, visual inspection didn't reveal any significant change in characteristics due by the flames. These works were considered to still constitute effective parades against the fall of small-sized rock blocks. After the event, the frequency of falls of blocks of a few liters increased; this increase was observed through the stones stopped in the nets and some small walls. No change was noted concerning large volumes.

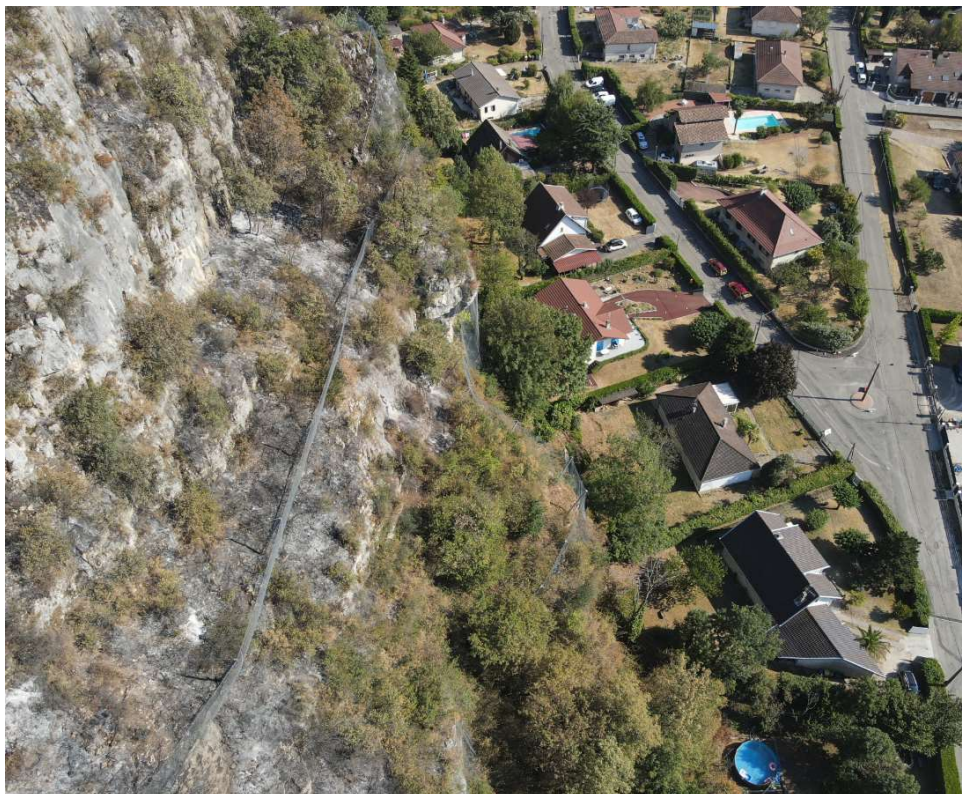
Figure 9 : Condition of the Balmes structures; central section (metal mesh) upstream of the built-up areas. The structures and vegetation in the lower part of the ledges are in good condition. (source: SDIS 38 – 09/08/2022)

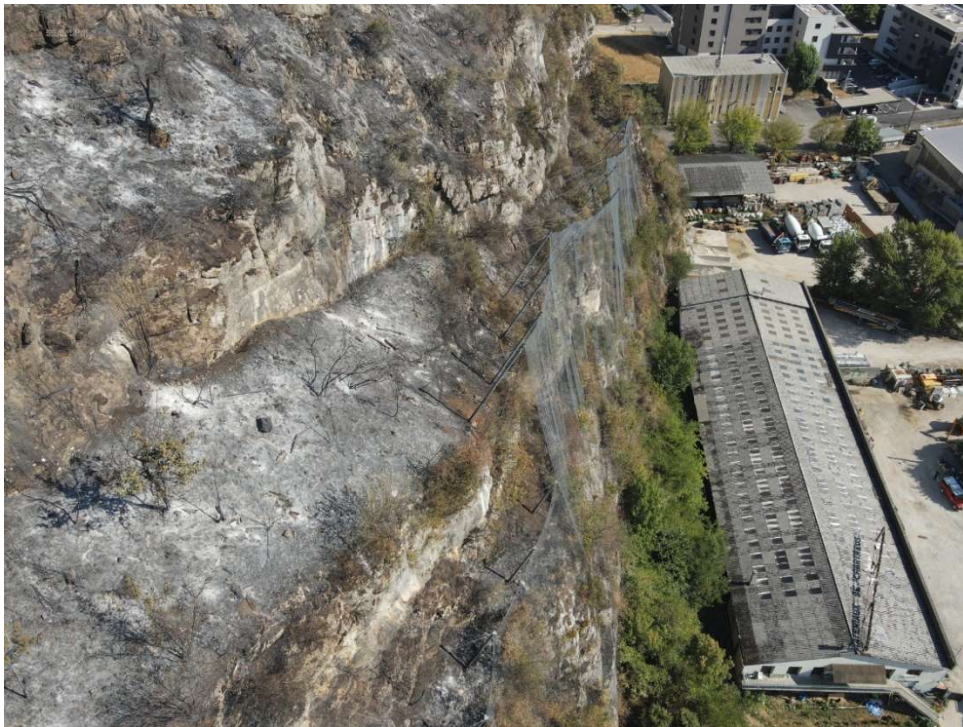
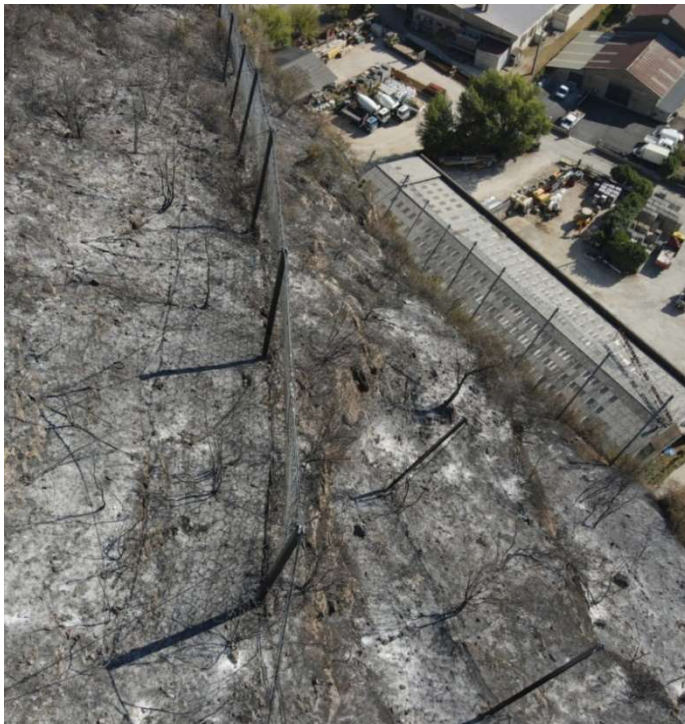
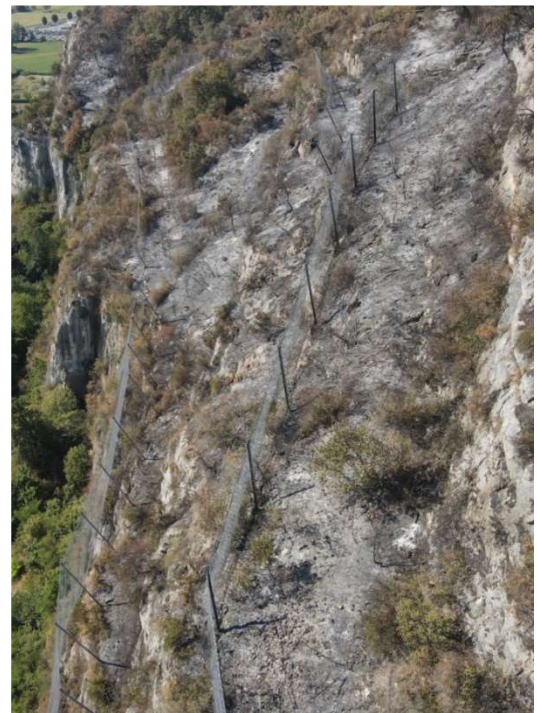
Figure 10 – View of the structures at Les Balmes; southern section (metal netting) upstream of the built-up areas. (Source: SDIS 38 – 9 August 2022)
